THE CURLY CASE OF THE CORRODING CHLORINE PIGTAILS

Sylvia Campbell, *Process Engineer-Water Supply Northern
Operations,*

Melbourne Water

*79th Annual WIOA Victorian Water Industry Operations
Conference and Exhibition
Bendigo Exhibition Centre
31 August to 1 September, 2016*

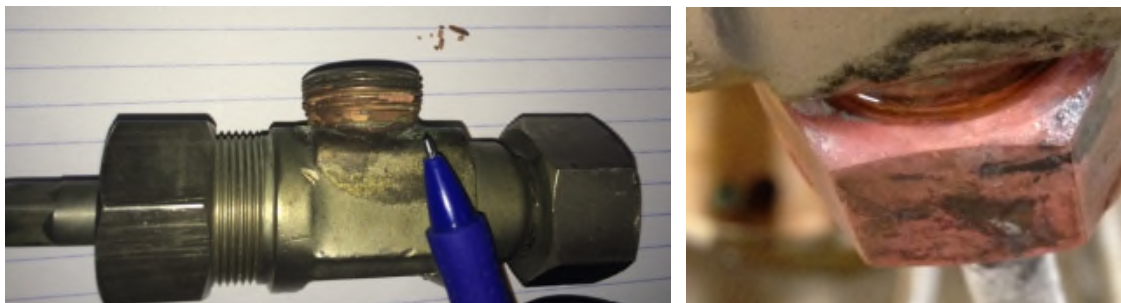
An incident response team was formed with the objectives to maintain safety of all Melbourne Water staff, contractors and the general public, to maintain supply of safe drinking water and recycled water, and to identify the root cause. An inspection at Greenvale found some valves with threads partly eaten away but external plating was intact. Missing or brittle threads presented a risk of loss of containment of chlorine. The incident response team arranged for an urgent inspection of valves at all chlorine drum sites.

Figure 2: *Brittle threads on valve (left), moisture in pigtail nut at Greenvale (right)*

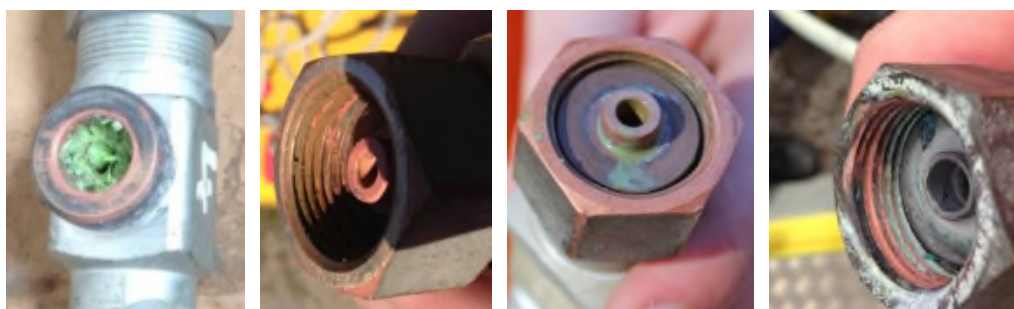
Inspection of disconnected valves and pigtails at WTP, Greenvale, Cardinia, Silvan and Tarago treatment plants found a range of internal and external corrosion symptoms including plating discolouration or removal, coloured corrosion products, moisture, brittle or removed threads and pink colouring indicating dezincification of valve surfaces and even internal threads and brass packing components in some cases.

Figure 3: *Observed corrosion symptoms (L to R): 1 green precipitate, 2 pink dezincified surfaces, 3 green moisture, 4 white/brown corrosion/plating removal*

Affected equipment will be engineered out or substituted. Valves will be replaced with bronze valves, airtight caps and different flexible connections where feasible. PTFE gaskets with a smaller inner diameter are currently being trialled. The following administrative controls will also be implemented or updated to mitigate the likelihood of future corrosion. A single standard operating procedure will be developed which incorporates drum changeovers, nitrogen purging, pressure testing and leak testing, and tightening of connections to achieve a seal. Guidance for valve condition assessments in maintenance instructions and improved asset information records will also assist with data collection to monitor corrosion trends. These actions were adopted based on the incident analysis report from July 2016 and will be implemented throughout the remainder of 2016. While the corrosion issues have not been resolved at the time of writing, it is anticipated that the implementation of these actions will remove the incidence of valve and pigtail corrosion.

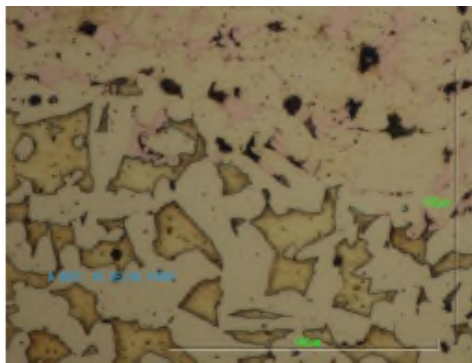
Brass can be a single phase structure (alpha phase) or two phase/duplex structure (alpha-beta phase). Dezincification is more likely in the latter. Laboratory analysis showed that the brass had an alpha-beta microstructure and hence was susceptible to dezincification.

Figure 4: *Microstructure analysis of a Greenvale valve showing alpha-beta structure: beta phase (darker patches) in alpha phase (lighter coloured background)*

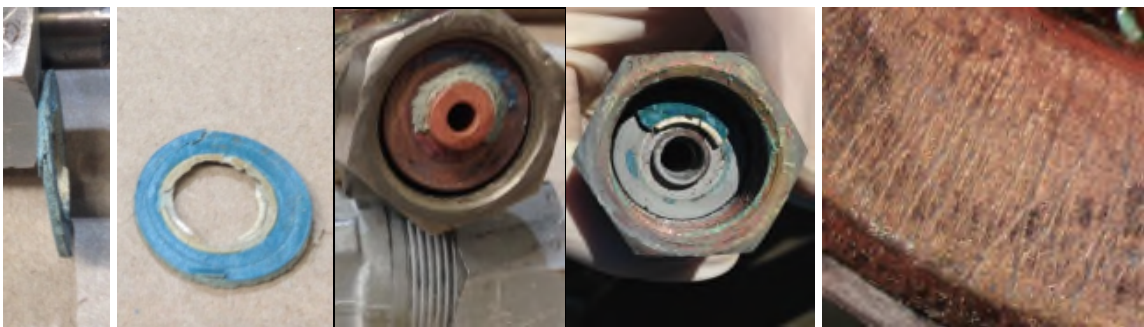
Discussions with the valve supplier suggested that discolouration of pigtail nuts indicated a very low level chlorine leak below detection limits indicating that these connections had poor seals. Gaskets are used to seal the pigtail/auxiliary connection and the auxiliary/drum valve connection. Gaskets used were 1.5mm thick Tesnit (aramide fibre). Operators reported that the gaskets currently used had a larger inner diameter than older gaskets from years ago and the new ones were more prone to slip when installed. Inspection of valves found that some gaskets were worn, torn, unevenly compressed or in some cases broken into pieces when the pigtail nut was disconnected which suggested overtightening. The gaskets commonly stuck to the sealing surfaces and had to be removed with scrapers or wire brushes to clean the valve sealing face before applying a new gasket. Optical assessment of valve sealing faces showed track marks from wire brushing which may have allowed chlorine to pass around the gasket in older valves. There was no common tightening method or understanding of how tight a connection was needed to achieve the correct compression of the gasket to create a seal. Torque wrenches had been trialled unsuccessfully in the past and were not used for connections.

Figure 3: *1. Unevenly compressed gasket, 2. Torn gasket, 3. Gasket stuck to sealing face, 4. Broken gasket, 5. Scratches on valve sealing face*
