WATERWORKS

TECHNICAL PUBLICATION OF THE WATER INDUSTRY OPERATORS ASSOCIATION OF AUSTRALIA

COEXISTING WITH TELCOS

IMPACT OF TELCO STRUCTURES ON WATER STORAGE RESERVOIRS

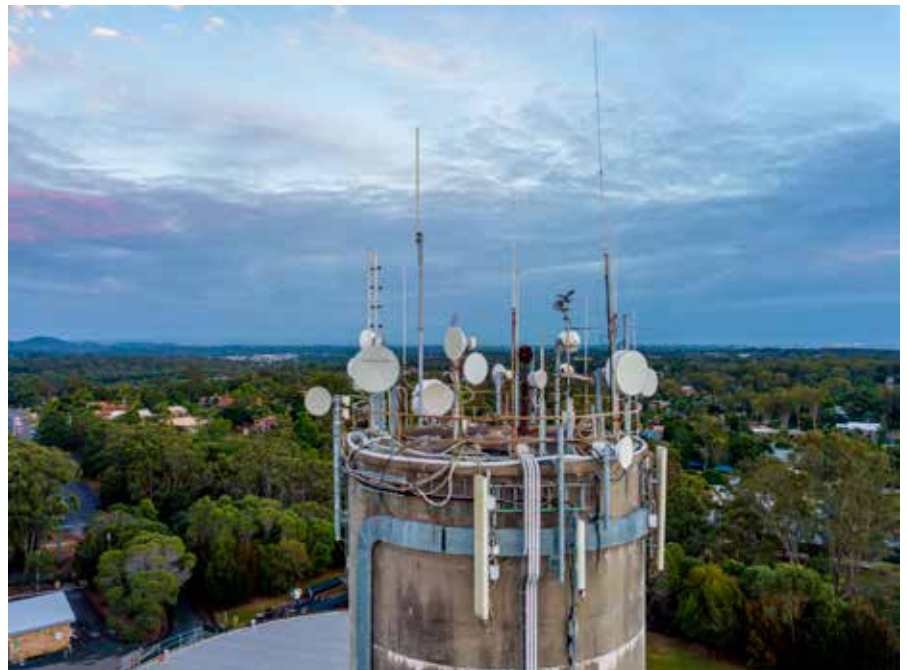
Figure 1. Access to the roof of this storage is all but impossible.

One of the major consequences is that Water Utility staff are no longer allowed to access some structures, and in particular the roof because of the level of radiation and, in some cases, simply a lack of space (Figure 1).

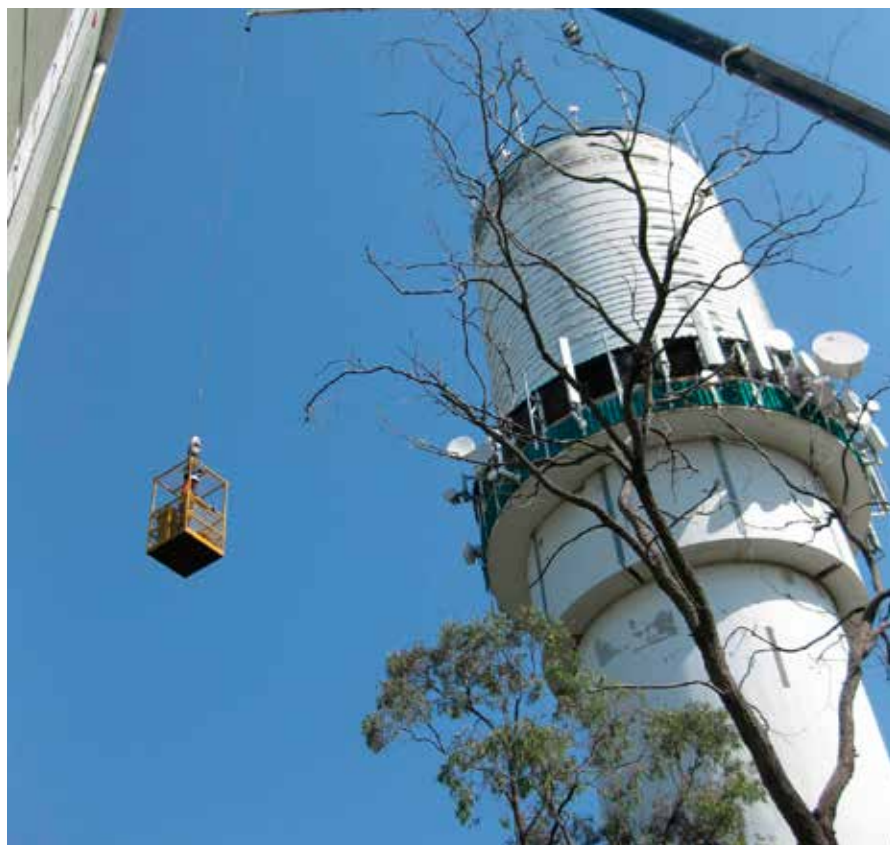
Figure 2. A crane is the only way to access some reservoir due to Telco impacts.

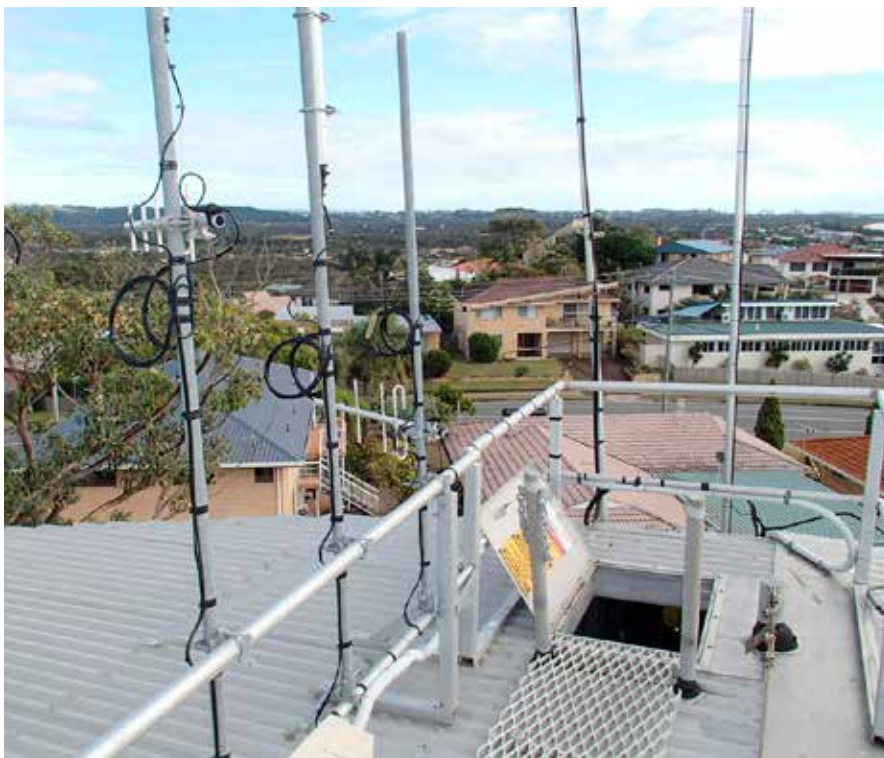
Figure 1. Reservoir entry hatch fully surrounded by aerials.

Some EME guides do not list or identify the tank features, making it difficult to gain a perspective and determine if the EME exclusion zones encroach on the entry hatch to reservoirs or access stairs (Figure 1). These EME guides need to be reviewed before visiting sites, and to view if any "limited" conditions exist such as the presence/exclusion of unknown antennas. This is making the determination of safe work areas difficult, thus impacting on worker safety. Site owners should check that the EME Guides are up to date, accurate and clearly detail all EME exclusion zone clearances. It is also good practice to leave a copy of the EME guide on site for the use of

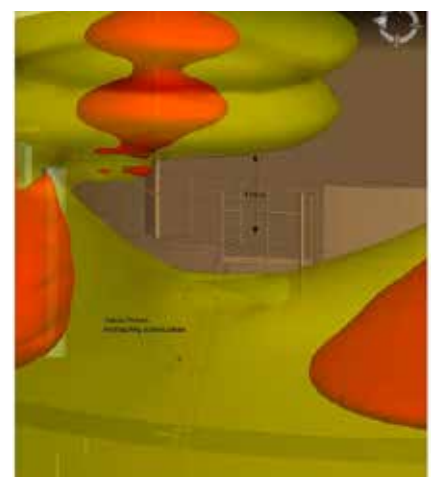
Figure 2. RF emission plume over an access ladder.

Positioning of Telco equipment has occurred in the past without due regard to the operational and functional requirements of the tanks. In some examples, this has led to site owners being unable to access the tank roof area due to emission zones over the ladders, or antennas installed on the roof area limiting the ability to carry out emergency, routine and maintenance requirements (Figures 1 and 2). This can lead to a loss of control of a site owner's ability to manage its assets. This can also be in conflict with a site owner's statutory obligations to ensure the water is safe to drink or to maintain continuance of supply of drinking water to the public.

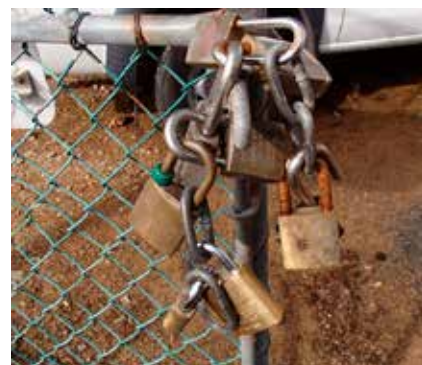
Figure 4. Daisy chain of (whose?) locks.

Often when attending sites with Telco equipment, there are additional padlocks on the gates for these companies to access the site independently. In the past, where the asset owner has restricted these by removing any unknown locks, they have attended the

site later only to find that the chain has been cut and additional locks installed without the site owner's consent (Figure 4).

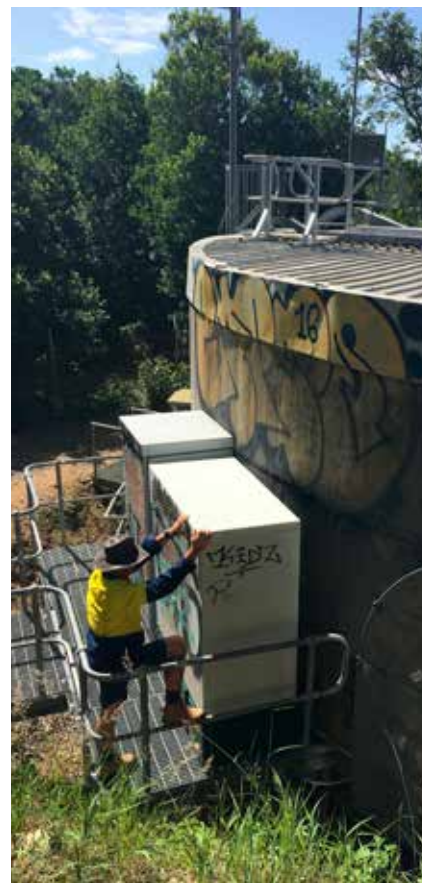
Figure 5. Telco fixtures allowing unauthorised access to tanks.

Site security can be further compromised by having additional Telco fixtures, such as site huts, cable frames and cabinets on site that allow vandals to bypass fences or security ladders (Figure 5). Sites have been compromised when subcontractors for the Telcos have installed scaffolding or left equipment within a locked site allowing local vandals to climb and conduct acts of vandalism.

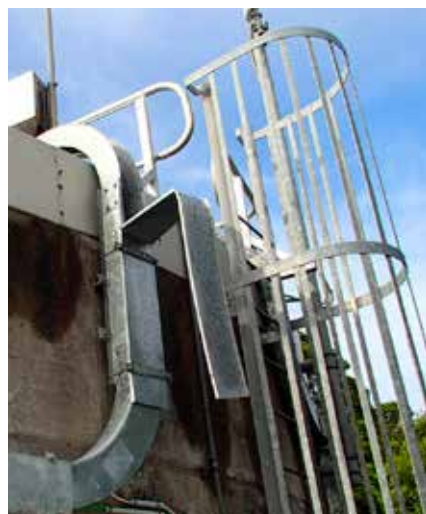
Figure 3. Cable cover defect.

This can occur with installation of cable trays running across access areas causing trip/slip hazards. Cable tray covers also require ongoing maintenance, and numerous covers have been found unattached on site or in neighbouring areas after being dislodged during a wind event.

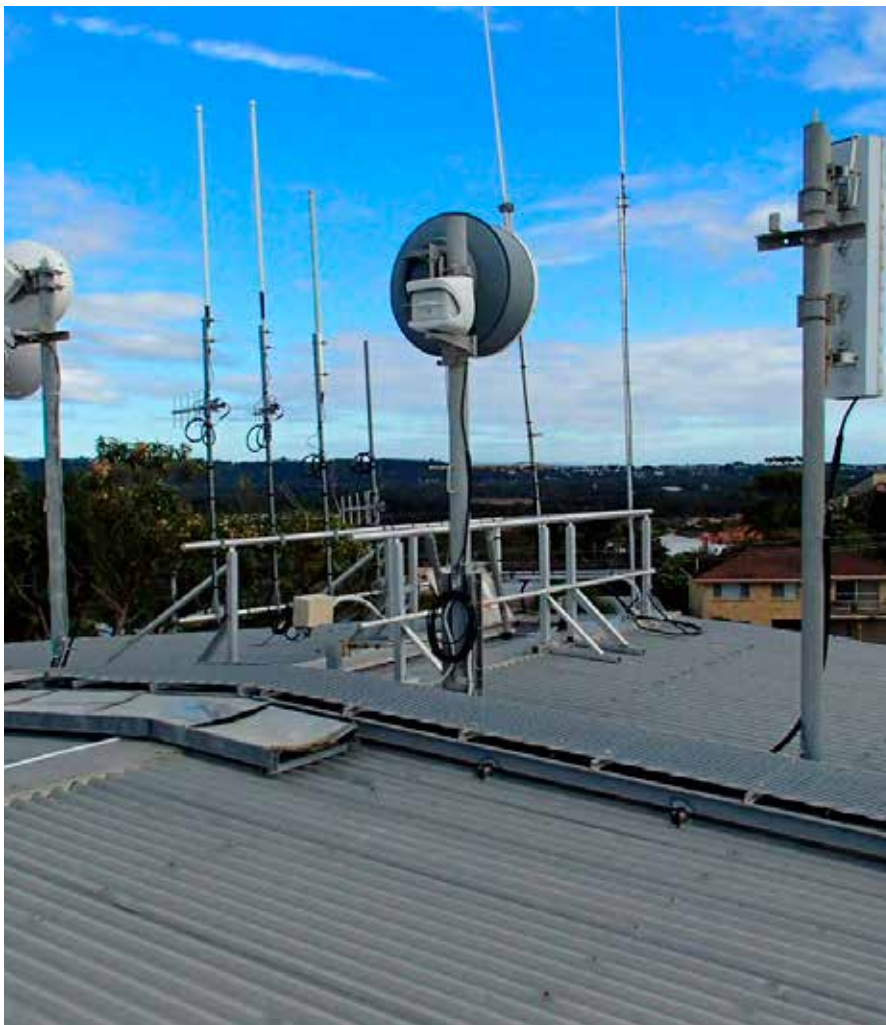
Figure 6. Roof aerials poorly “fixed” directly to roofing materials.

- Local impacts on reservoir structures due to additional point loads and bending moments, including wind loads (Figure 6).
- Damage to the waterproofing due to poor workmanship of the installation of the fixtures supporting the telecommunications equipment.
- Damage to concrete surfaces, including drill holes remaining unsealed or unrepaired and thus allowing moisture into the concrete surface that, in turn, can potentially lead to concrete degradation and steel reinforcement corrosion within the structure in the future. This is particularly a concern where reservoirs are located in a coastal environment, and the presence of chloride can initiate the corrosion process, resulting in loss of steel sectional area and cracking, delamination and spalling of the cover concrete well before the intended design life of the structure is reached.

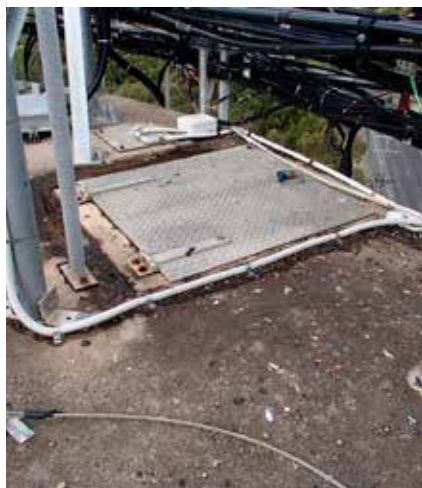
Figure 7. This structure promotes bird roosting and blocks roof runoff.

Birds are attracted to antenna structures for roosting and protection. This increases the risk of faecal material building up on the roof and can increase the risk to water quality (Figure 7).

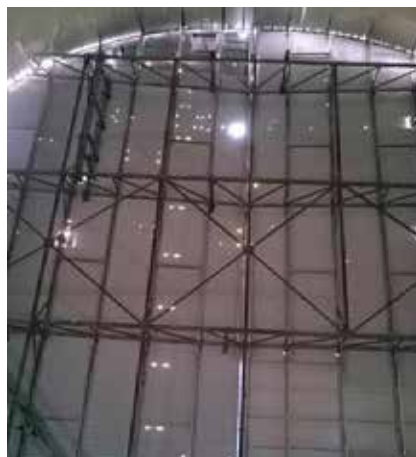
Figure 8. "Swiss Cheese" effect from Telco roof penetrations (looking up from inside the tank).

Holes in roofs from anchor points, or other fixtures (Figure 8), can also allow roof drainage to enter tanks and can lead to contamination of the drinking water supply.
